Simon Properties - Shoney's Pier Park Color Stability Analysis Original Application Date: February, 2013

Background:

Shoney's building located in Panama City Beach, Florida was coated with TEXCOTE[®] COOLWALL[®] SUPERCOTE[™] SMOOTH TEXTURE SYSTEM over hardy plank. It was coated in February of 2013 incorporating IR reflective technology and evaluated for color change over time. The color used is called Stop Red. Color change readings (DELTA E values) were taken using an X-Rite portable Spectrophotometer, Model SP60. All DELTA E values were calculated using CIE DELTA E criterion.

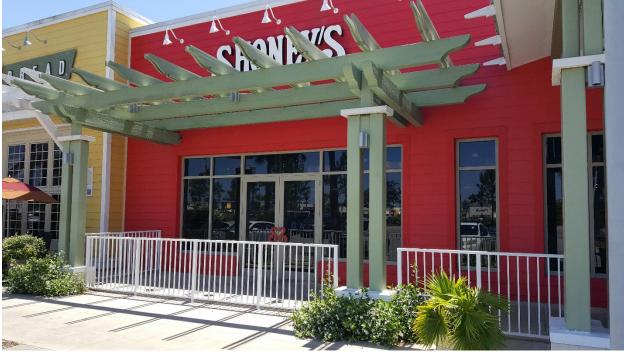
Northern Exposure

The average values of these color readings that were taken are shown in the chart below. These Delta average values were taken after 49 months of exposure. Panama City weather in Florida, USA has an average annual rainfall of over 80". The climate in this region ranges from the low teens in the winter to over 100° Fahrenheit with 100% humidity during the summer. These walls have been exposed to harsh weather conditions such as heavy rain, salt air, ultraviolet light from the sun, high humidity and high winds. Our TEXCOTE® COOLWALL® SUPERCOTETM SMOOTH TEXTURE SYSTEM demonstrates outstanding color retention after 49 months of exposure, especially with this red, one of the hardest colors when exposed to UV light. Conventional exterior reds, after these periods of exposure, usually have Delta averages of 20 units or more. These coated walls also do not show any sign of mold growth, including the North side, chalking or cracking of the coating and show an excellent resistance to dirt pick-up.

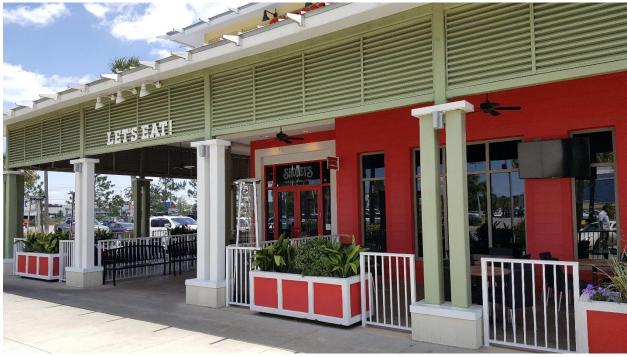
Western Exposure

This TEXCOTE® COOLWALL® SUPERCOTETM SMOOTH TEXTURE SYSTEM has an outstanding color retention and excellent water repellency after 4 years due to Texcote® IR technology. After 49 months, this bright red color continues to exhibit an amazing ability to retain color fastness and resistance to color fading. Also, our reds move to the blue or darker side so any delta change is less visually noticeable than the competition that typically moves to the lighter or pinker side!

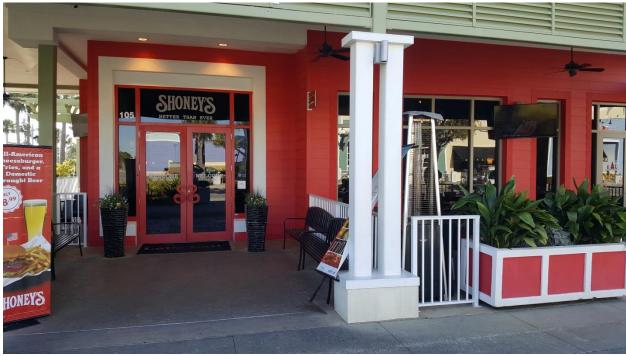
Western Exposure Flower boxes were painted the same color but with conventional paint
